Surface deformation produced by the 1999 Chi-Chi (Taiwan) earthquake and interactions with built structures

U. S. Geological Survey
National Earthquake Hazards
Reduction Program
Award Number 01-HQ-GR-0122

William Lettis & Associates, Inc.
1777 Botelho Dr., Suite 262,
Walnut Creek, CA 94596

December 2003

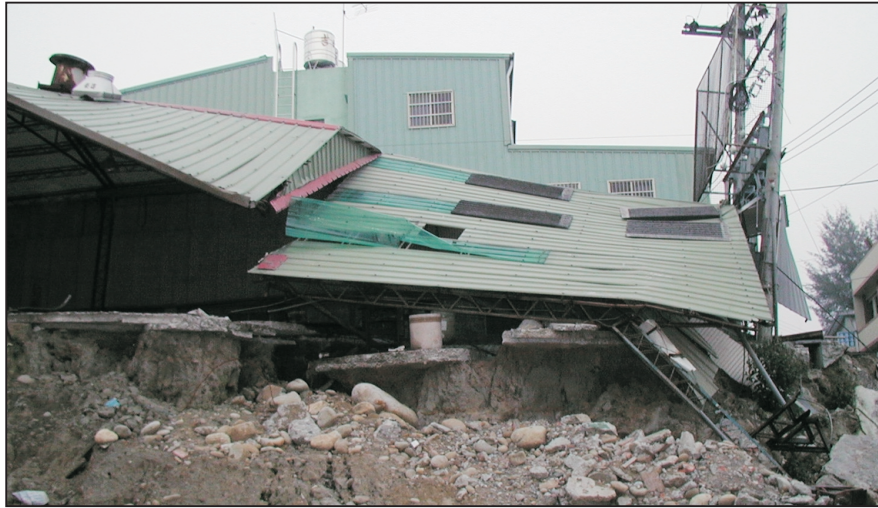
Figure 2a. Photograph of building on crest of Chelungpu fault scarp near Fengyüan, showing damage to thin-slab foundation. Vertical uplift at this site is 4m. Note multiple cracks in foundation.

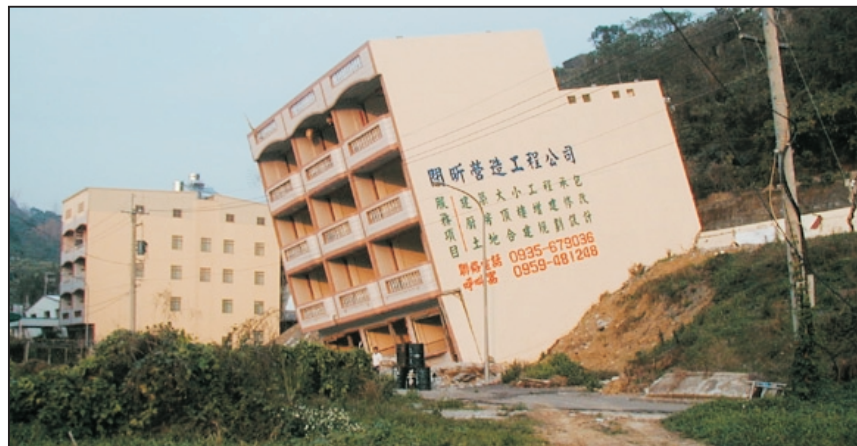
Figure 2b. Photograph of Chelungpu fault near Fengyüan, showing structure tilted by thrust faulting and uplift of about 4m. Building at left is of similar construction, but was relatively undamaged because of location on footwall.

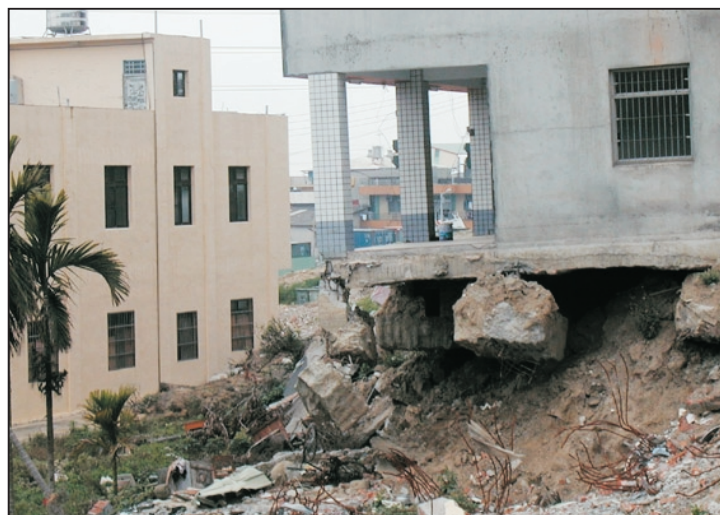
Figure 2c. Photograph of Chelungpu fault scarp near Fengyüan, showing uplift on fault of about 4m.

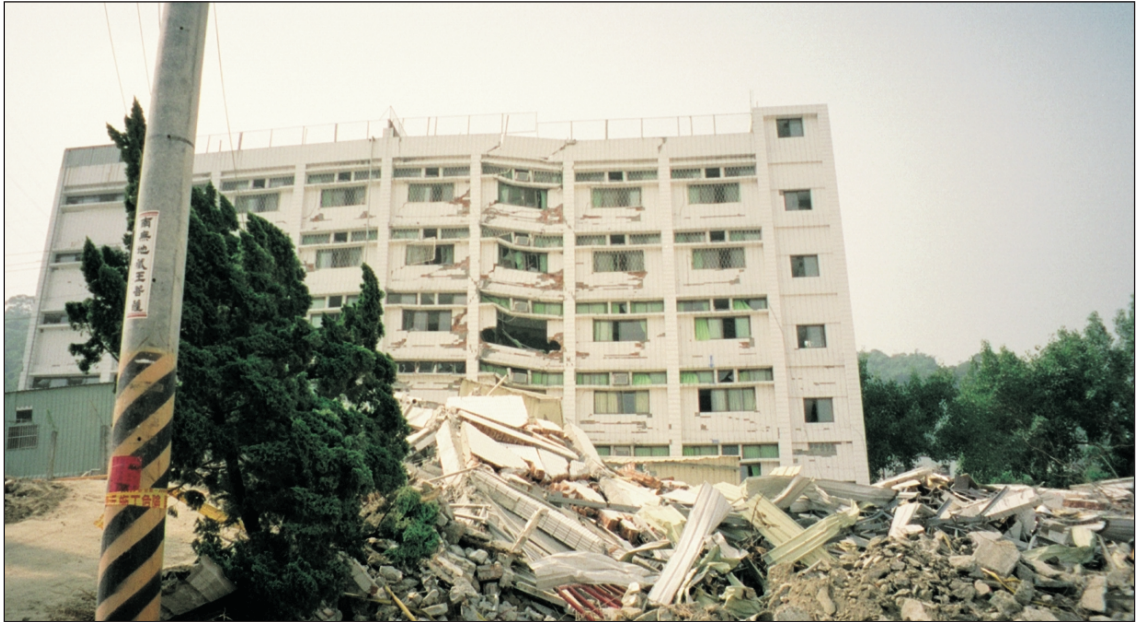
The most severe geologic deformation (and thus building damage) associated with surface rupture along the northern part of the Chelungpu fault occurred along the primary reverse-fault scarp. Substantial damage nearly always occurred to buildings or other structures spanning the fault rupture, as a result of differential vertical movement, severe tilting and/or westward translation (Kelson et al., 2001a). As might be expected, buildings with thin concrete-slab foundations generally sustained severe damage where located on the fault scarp (i.e., Figure 2a). Although several buildings with massive, reinforced foundations were damaged along the fault, there are examples of such structures undergoing severe tilting without collapse (Figure 2b), or vertical uplift without severe internal deformation (Figure 2c). Rarely, buildings spanning the fault rupture were able to withstand surface displacement without collapse (Figure 3).

Figure 3. Photograph looking south along Chelungpu fault rupture in Wu Feng. The fault rupture passed beneath this apartment building, producing displacement of the building. [Photo taken; October 11, 1999].

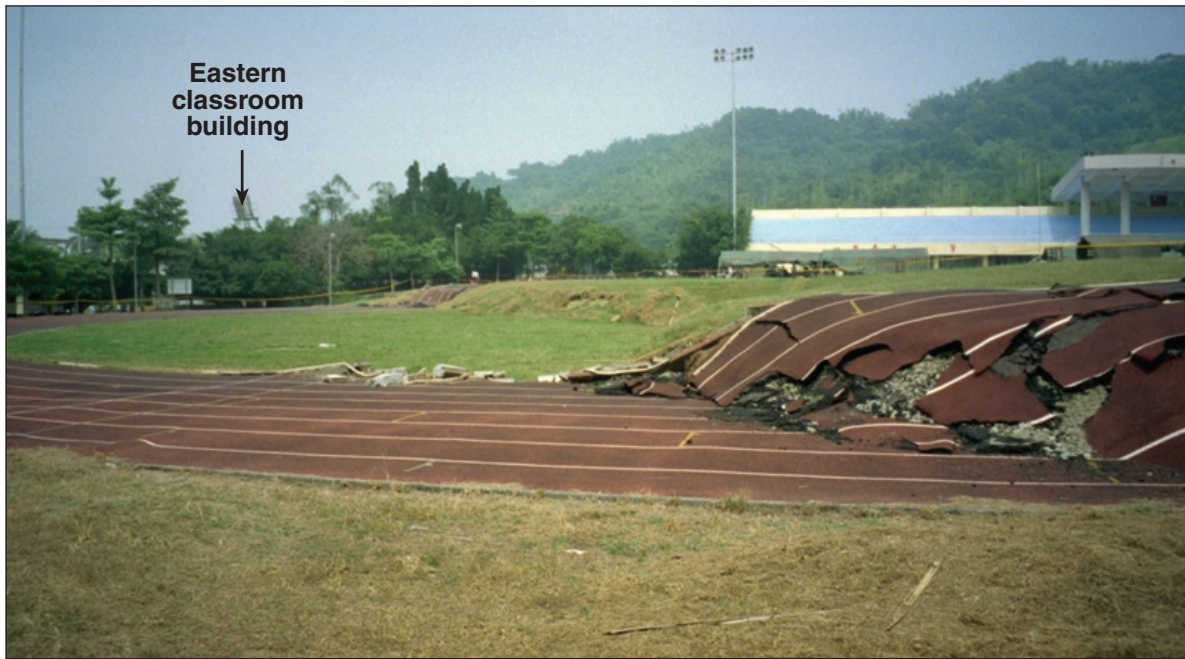
The deformed track at the KuangFu Middle School has received abundant attention, in part because the surface deformation is strikingly clear (i.e., <http://geot.civil.metro-u.ac.jp/archives/eq/99taiwan/>) (Figure 5). As part of our early post-earthquake efforts in characterizing the fault-related surface deformation (Kelson et al., 2001a), detailed topographic surveying of the N45°W-trending fault scarp where it crosses the track and field showed a net vertical tectonic displacement (NVTD) of 2.8 ± 0.5 m. We also noted that this single scarp splits into three strands in the area north of the track, where the fault zone crosses the school campus. The total NVTD of the fault zone through the school and along a road bordering the northern margin of the school is comparable to that at the track (Kelson et al., 2001a). Additional reconnaissance of the school campus showed that buildings and other structures located on the hanging wall but more than about 40 m from the fault scarp experienced minor or no damage (Kelson et al., 2001b). Because the severity of damage to school buildings on the footwall is atypical, Kelson et al. (2001b) speculated that westward thrusting of buildings located astride the fault scarp impacted the adjacent buildings on the footwall, resulting in damage or collapse of the footwall buildings. In addition, we noted that specific buildings were spatially associated with fault bifurcations, and speculated that the “Eastern Classroom Building” (see Figure 6) might have influenced the pattern of surface fault rupture and contributed to the occurrence of multiple strands in and north of the campus.

Figure 5. Photograph of 3 meter high fault scarp crossing the Kuangfu Middle School track and field. Eastern Classroom building is behind trees in background, and has the tilted water tank on its roof (photo taken October 11, 1999).

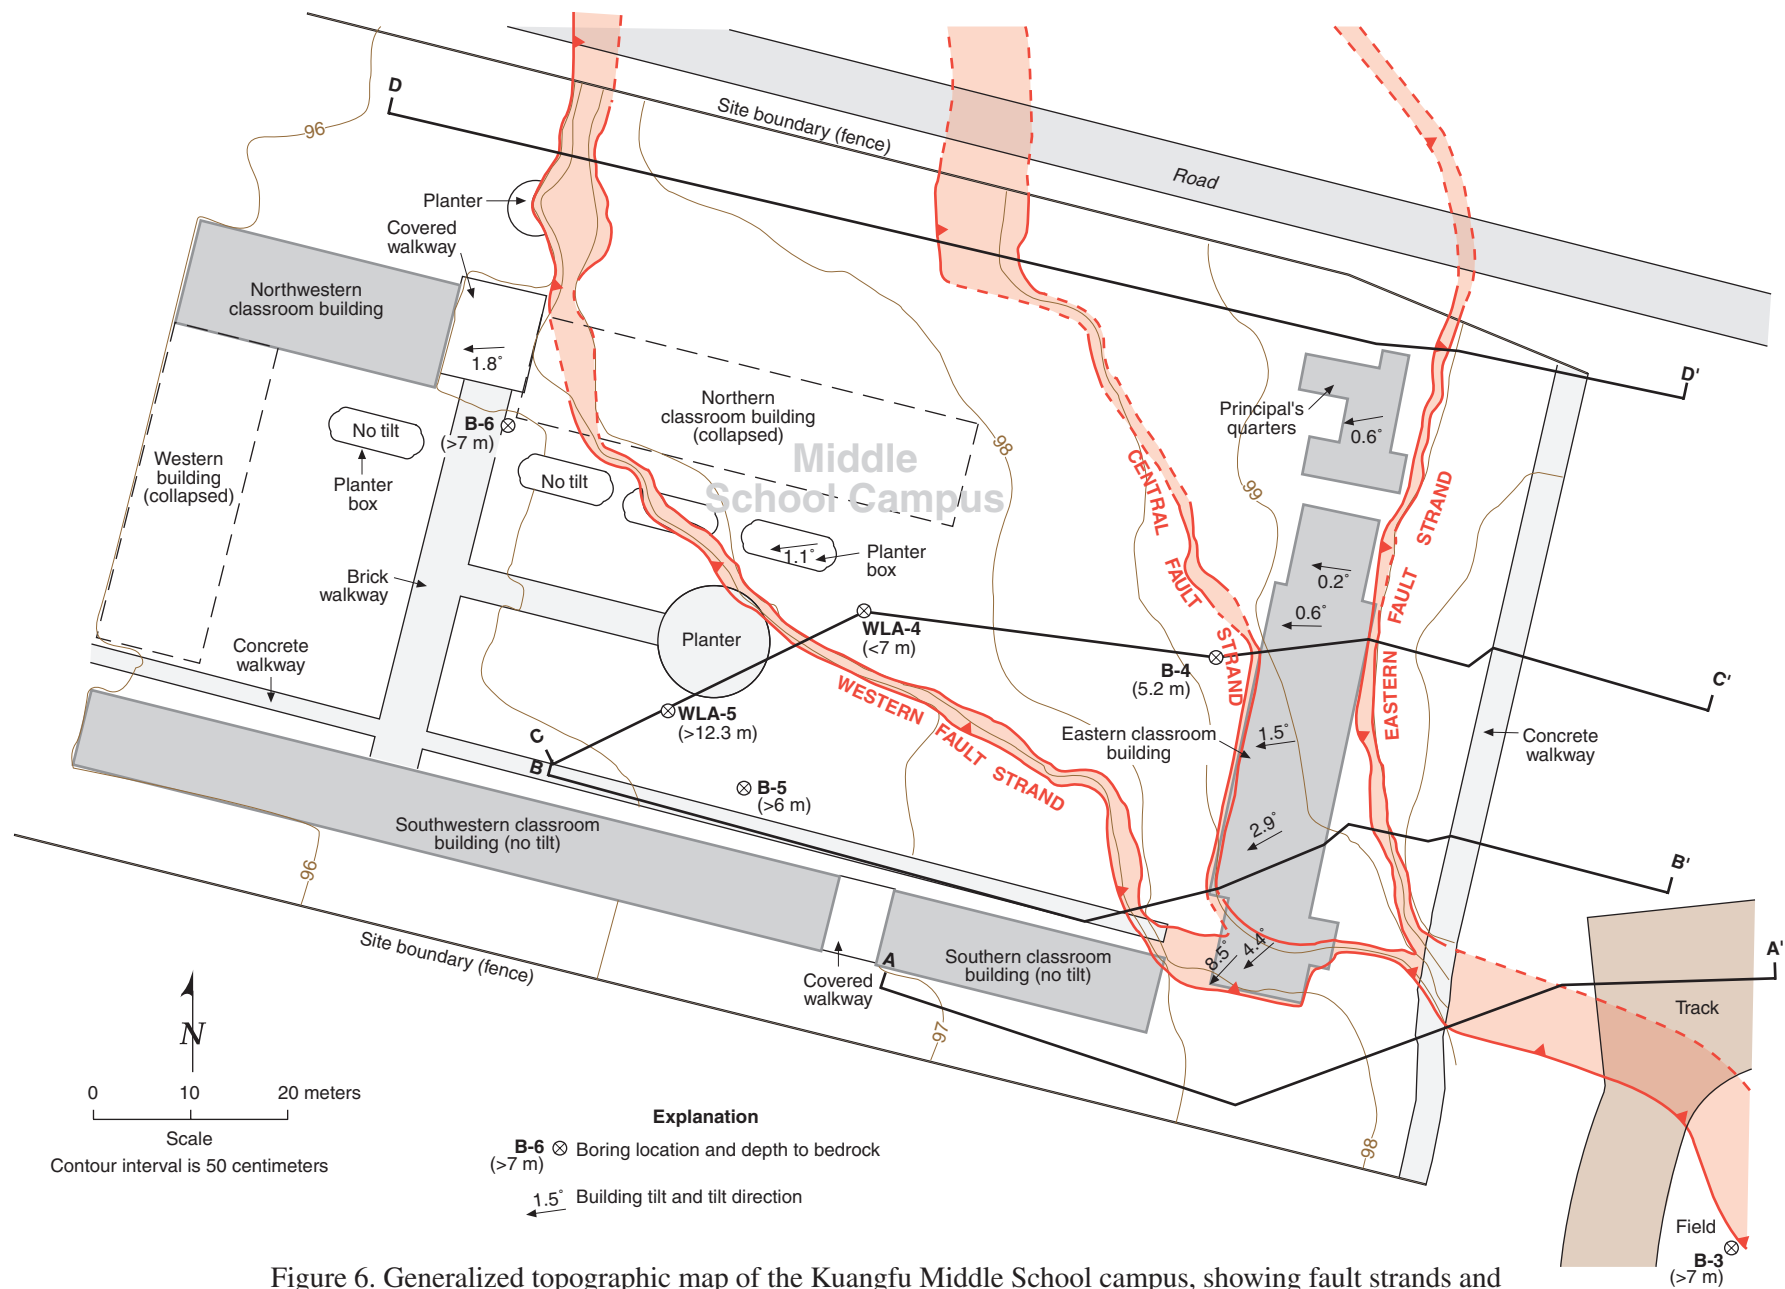
On the basis of the survey and borehole data, we interpret that the patterns of ground deformation and building damage at the Kuangfu Middle School are intimately related. In particular, it seems that the location and orientation of the buildings may have influenced the pattern of ground rupture produced by the 1999 earthquake. First, the Chelungpu fault in the site vicinity is primarily a single fault strand, with the exception of the three scarps that traverse the school campus, suggesting that the three rupture scarps through the campus are unique. Second, two of the scarps are secondary strands that die out to the north, such that the total uplift is transferred back to the single western fault strand present north of the campus. Third, the pre-1999 trace of the fault differs from the 1999 rupture locally where it encounters the school buildings, suggesting that the pattern of the 1999 rupture is different from previous rupture patterns. And lastly, the location and character of the scarps through the campus appear to be influenced by the building locations and orientations. This last point is supported by the northerly strike of the eastern strand where it parallels the Eastern Classroom Building and the Principal's Quarters (Figures 4 and 6), and by the map pattern of the fault tip as it wraps around the southern end of the Eastern Classroom Building (Figure 6). Additional support includes the abrupt changes in strike of the western strand from westerly to northwesterly at the corner of the Southern Classroom Building, and from northwesterly to northerly where the fault encounters the Northern Classroom Building (Figure 6).

Figure 6. Generalized topographic map of the Kuangfu Middle School campus, showing fault strands and classroom buildings. Shaded areas along fault strands indicate fault scarp face. Boreholes B-1 and B-2 are located on playing field, southeast of B-3.

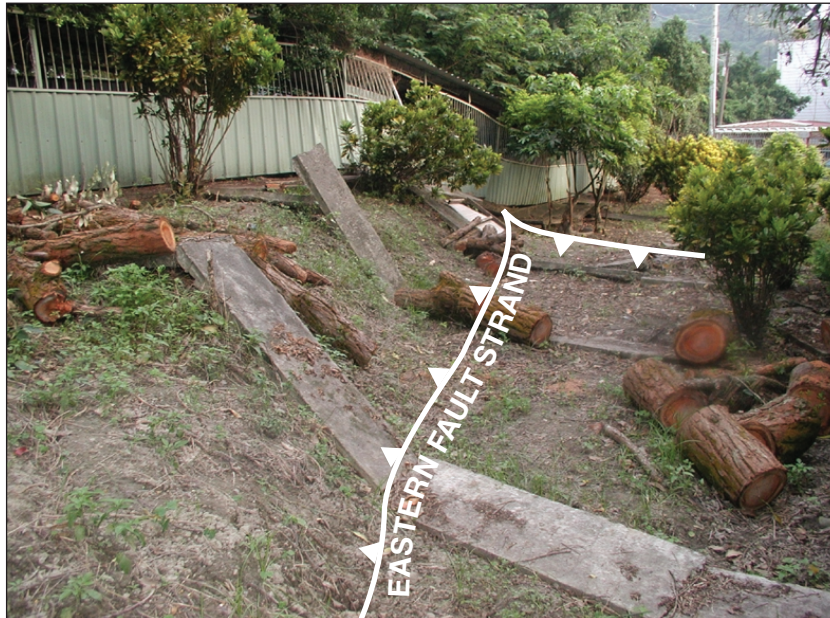
Figure 9a. Photograph looking south along eastern fault strand on the eastern side of the Eastern Classroom building, Kuangfu Middle School (photo taken June 8, 2001).

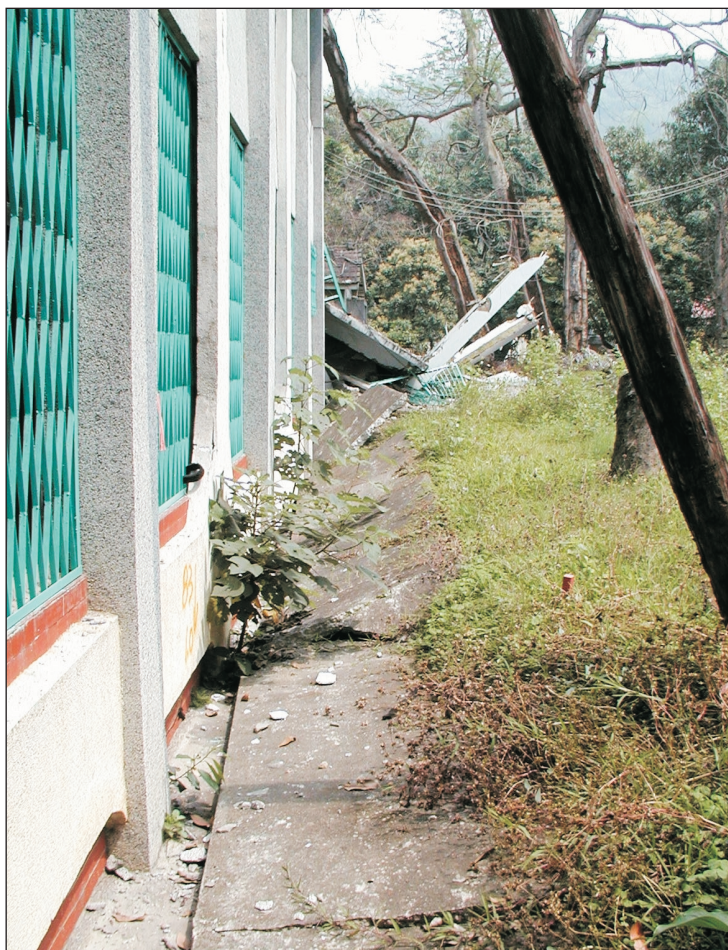
Figure 9b. Photograph looking north along eastern fault strand, along eastern side of Eastern Classroom building (photo taken April 11, 2000).

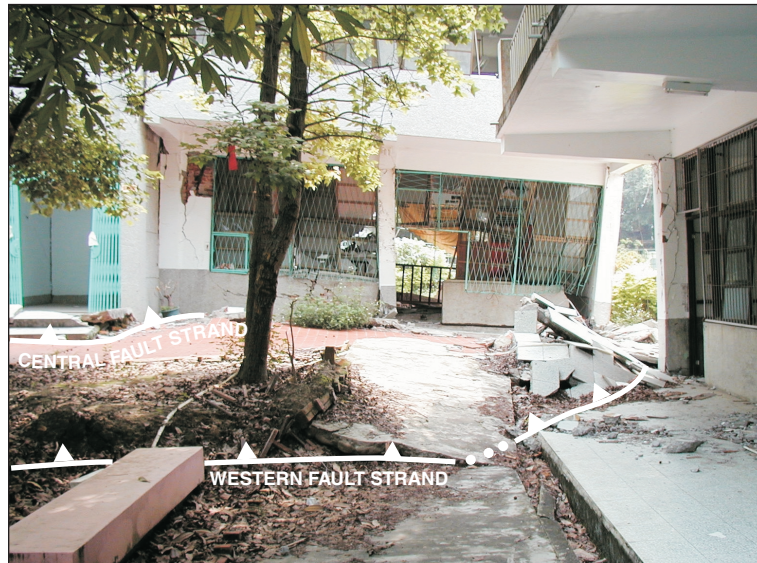
The southern end of the Eastern Classroom Building is severely damaged as a result of deformation associated with the western and central strand of the fault (Figures 5 and 10). The southernmost part of the building essentially overlies the western fault scarp, as reflected by the tilts of the building floor, which range up to 8.5° to the southwest (Figure 6). The fault tip wraps around the southern end of the building, and extends westward to the northeastern corner of the adjacent “Southern Classroom Building” (e.g., “Building C” of Kelson et al., 2001b). The entire Eastern Classroom Building is tilted southwestward, with the degree of tilting decreasing progressively from 8.5°SW at its southern end, to about 1.5°SW in a central classroom, to about 0.2°W in a northern classroom. This pattern of tilting may be related to deformation along the eastern fault strand (which borders the eastern margin of the building) and/or the central fault strand (which borders the western margin of the building) (Figure 6). Notably, the two-story Eastern Classroom Building contains a limited subsurface basement, located only at its southernmost end.

Figure 10a. Photograph of western fault strand at Kuangfu Middle School where it goes between the Eastern Classroom building, on left, and the Southern Classroom Building, on right (photo taken September 7, 2001).

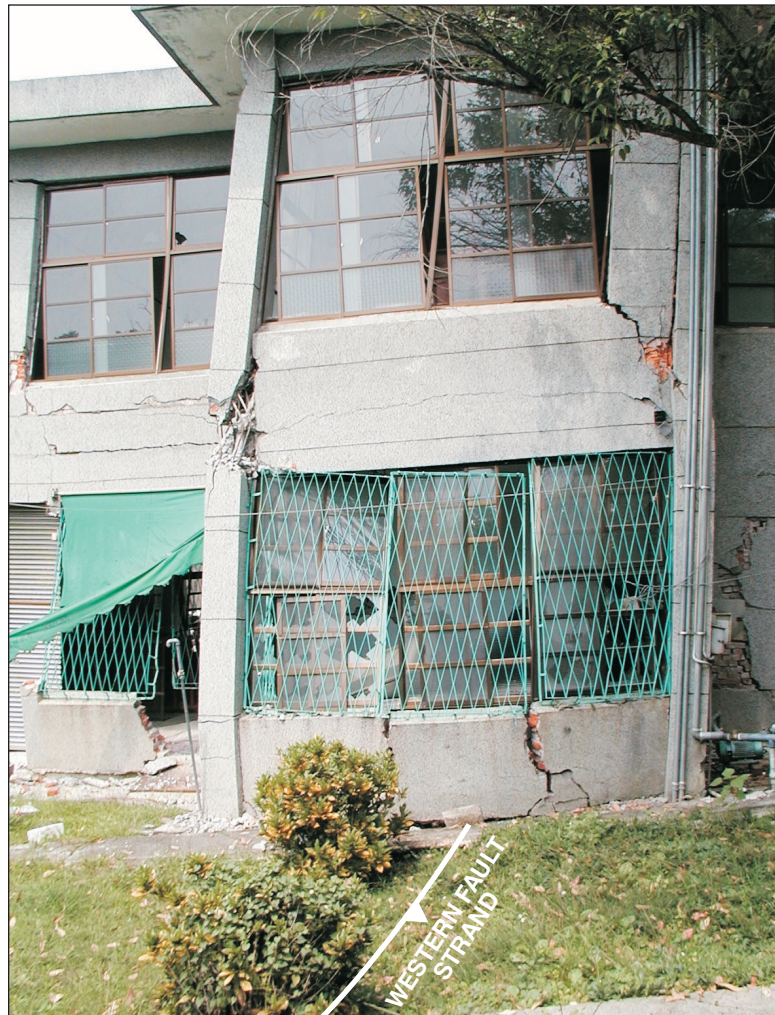
Figure 10b. Photograph of western fault strand where it encounters the Eastern Classroom building (photo taken April 11, 2000).

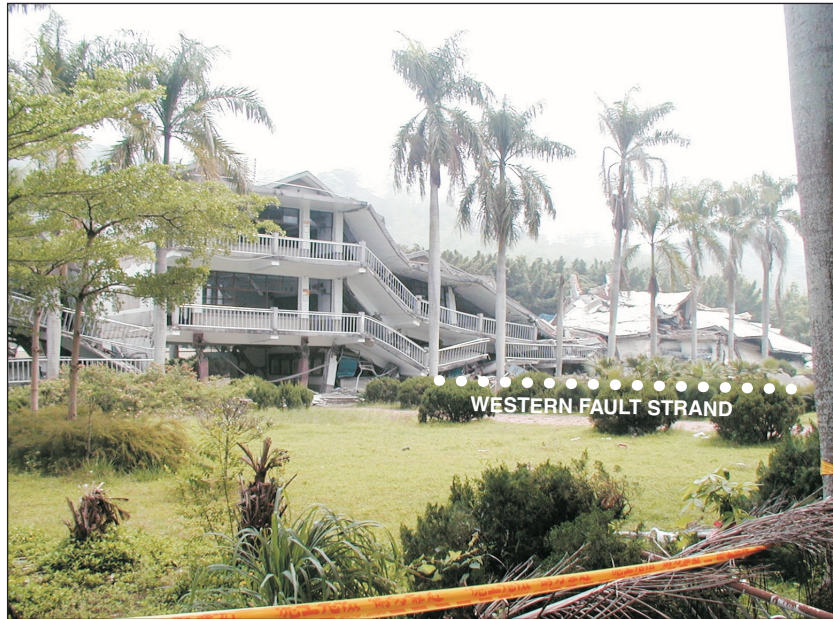
Perhaps one of the most graphic examples of building damage related to surface-fault rupture from the 1999 earthquake is the three-story classroom building in the northern part of campus (Figure 11a). The western fault strand traverses this building, which experienced total collapse on the hanging wall, and severe deformation and shortening at the fault crossing (Figure 11b). On the footwall, the building experienced severe structural damage and partial collapse probably related to the shortening and westward thrusting of the building's structural elements. The orientation of the western fault strand on the southern side of the building is about N50°W, but

Figure 11a. Photograph looking northeast toward the collapsed Northern Classroom building at Kuangfu Middle School, across the western fault strand (photo taken April 11, 2000).

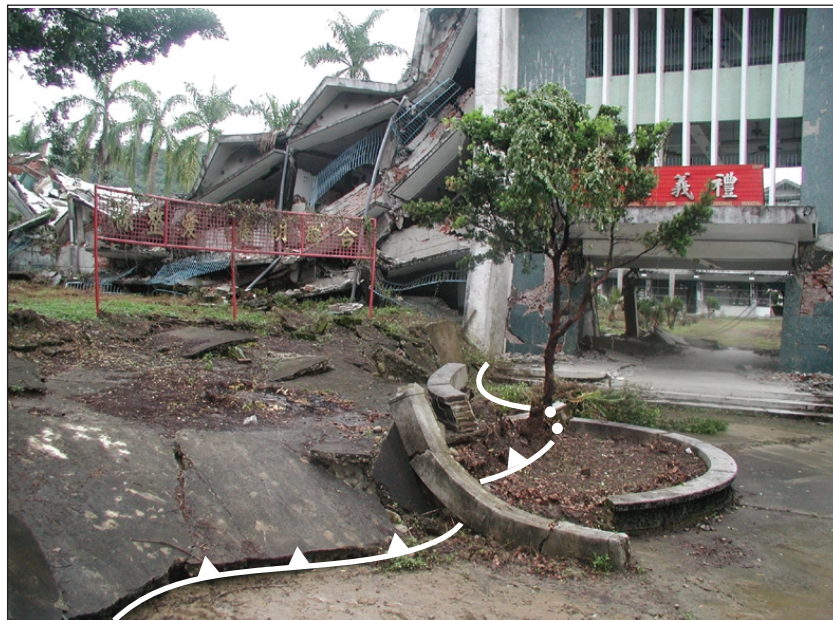
Figure 11b. Photograph looking southeast toward the collapsed Northern Classroom building at Kuangfu Middle School, along the western fault strand (photo taken September 9, 2001).

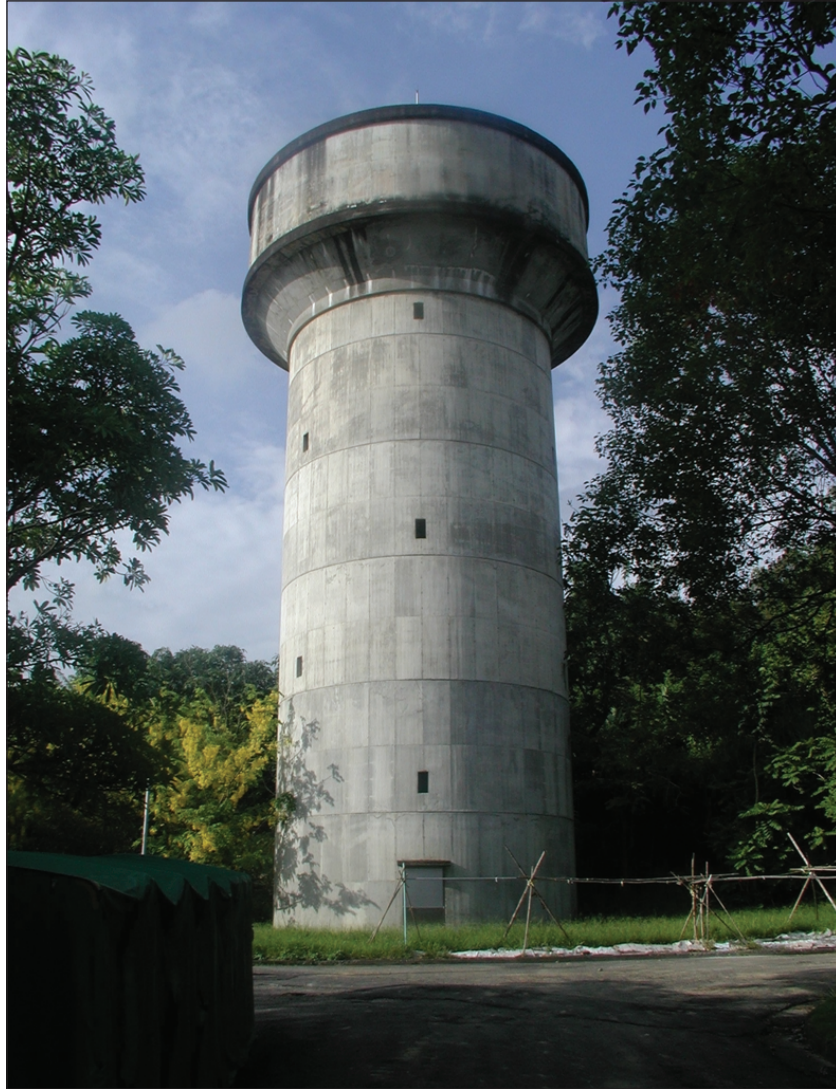
At the Tsaotun Municipal Water Tower site, we conducted detailed topographic surveying and geologic mapping of the fault rupture as it intersects the 9-m-wide, 27-m-high concrete water tower (Figure 14). Directly south of the tower, the fault rupture is expressed as a single, 1.5-m-high west-facing fault scarp that projects northward directly toward the water tower (Figure 15). At the tower, the fault scarp wraps around the eastern side of the tower, where anticlinal deformation of the hanging wall is substantial. A drainage ditch along the eastern margin of the tower is completely closed as a result of shortening. Directly north of the tower, the scarp bifurcates into two scarps within a zone of distributed folding and faulting. In this area, the overall trend of the deformational zone is similar to that south of the tower, and the adjacent drainage ditch is relatively undeformed. Our analysis of the deformation at this site involved constructing a detailed topographic survey of the area and several cross-fault topographic profiles. We also collected as-built plans of the tower from the local water company, which provide information on the tower geometry and its subsurface foundation.

Figure 14. Photograph of Tsaotun Water Tower looking east (photo taken June 9, 2001). Chelungpu fault is in shadows behind tower (not visible).

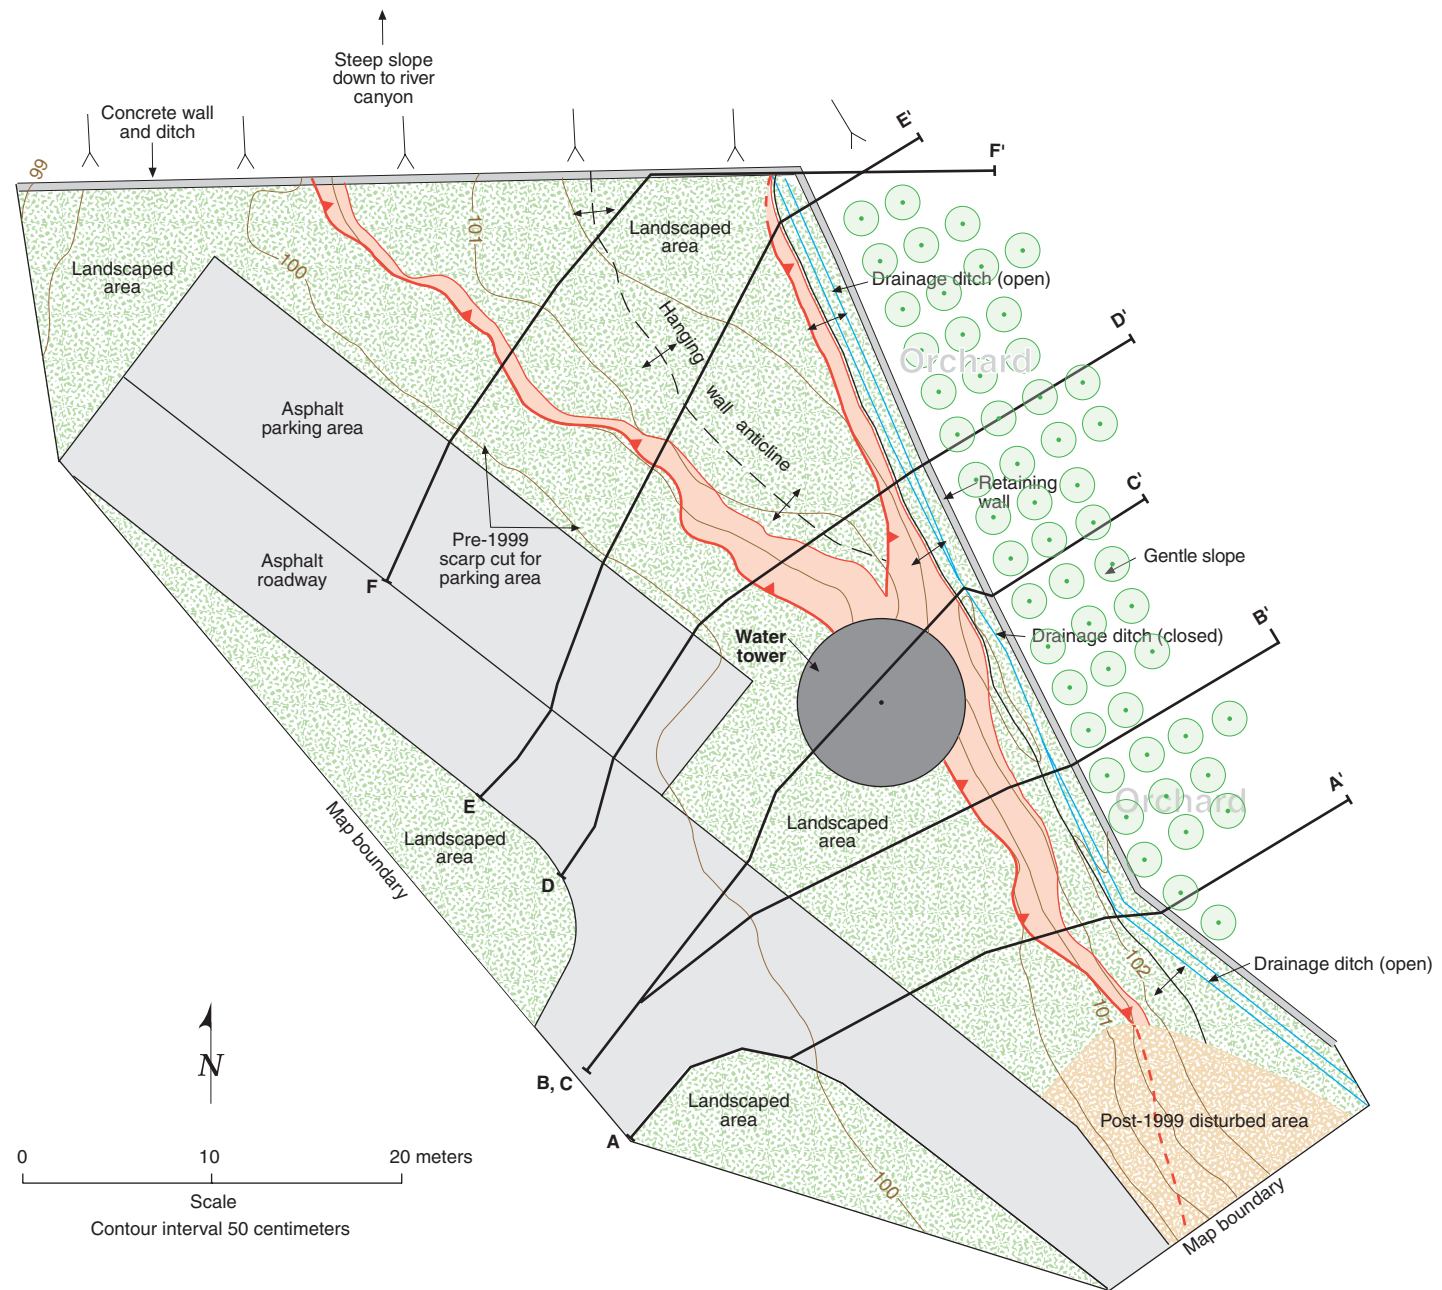
As noted above, the fault scarp projects directly into the base of the water tower, wraps around the eastern side of the tower, and then continues to the northwest (Figure 15). In contrast to the tilted betel nut trees located along the scarp face south of the water tower, the tower itself remains vertical. The soil material between the tower and the retaining wall is severely deformed and forms a sharp-crested hanging-wall anticline (Figure 18c). The drainage ditch along the base of the retaining wall is closed, in contrast to areas north and south of the tower, where it remains open. Based on our topographic profiling, the NVTD at this location along the fault is about 1.1 m, which is slightly more than the NVTD north and south of the tower. Assuming that the net horizontal shortening is the same along the fault scarp, the greater NVTD behind the tower suggests that the very uppermost tip of the fault has a slightly steeper dip (about 36°) in the local vicinity of the tower (Figure 18c). Because the tower shows no evidence of structural damage or tilting, it appears that the surface rupture had no significant impact on the tower's structural integrity, and instead that the tower itself may have influenced the local style of near-surface deformation.

North of the tower, the fault rupture splits into two strands: a western strand that strikes about N45°W and an eastern strand that strikes about N25°W and is parallel to the retaining wall (Figure 15). The total NVTD across the fault zone ranges from 0.6 to 0.9 m along the scarp north of the tower, and the fault tip daylights in the landscaped area along the western fault scarp

Thus, it appears that the presence of the water tower adjacent to the pre-1999 fault trace may have affected the distribution of deformation at the site. The divergence of the western strand away from the base of the retaining wall (and presumably the pre-1999 location of the fault tip) suggests that the majority of the surface deformation wrapped around the tower and developed farther west than that during previous surface-rupturing events. In addition, the surface rupture did not appear to significantly impact the integrity of the tower. Given that the tower foundation extends only 2.5 m into the shallow subsurface, it seems likely that either: a) the mass of the tower affected the dip of the fault in the very near surface, forcing it to steepen as it reached the ground surface, and/or b) the fault tip is farther east than the base of the retaining wall, and the material deformed behind the tower reflects merely “bulldozed” soil. In the latter case, the soil east of the tower was pushed against the lower 1.5 m of the tower and did not affect the base or foundation of the tower. In this case, as suggested by the complex scarp bordering the northern side of the tower (Figure 15), the bulldozed soil appears to have squeezed around the sides of the tower.

Figure 15. Generalized topographic map of the Tsaotun water tower site, showing fault strands, and location of water tower. Shaded areas along fault strands indicate fault scarp.

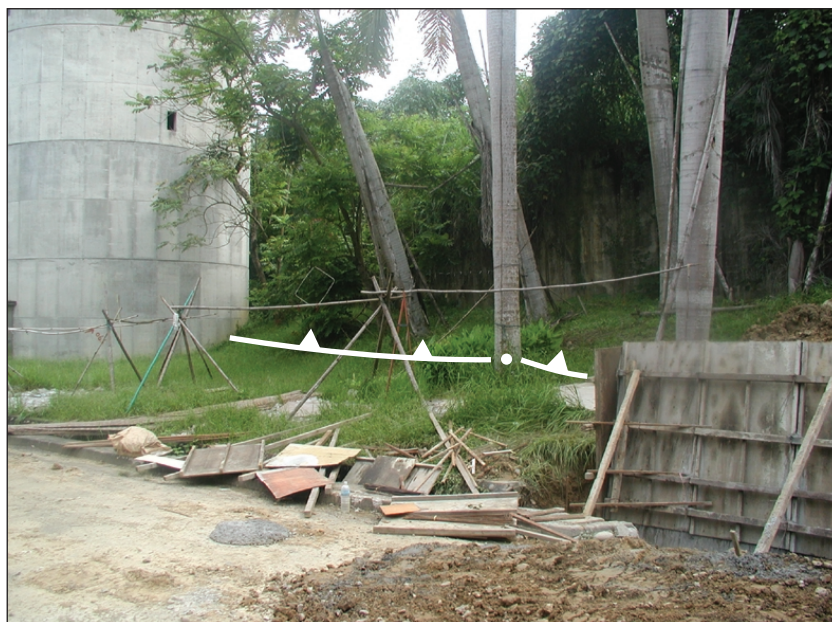
Our detailed survey documents the location and character of the 1999 surface rupture through the water tower site (Figure 15). South of the tower, the rupture consists of a single, 1.5-m-high fault scarp that strikes about N35°W (Figure 17). Topographic profiles across this scarp show that the deformation occurred primarily within a zone about 6 or 7 m wide (Figures 18a and 18b). Using the gentle slope of the landscaped area on the footwall, we estimate a net vertical tectonic displacement (NVTD) of about 0.8 m along both profiles A-A' and B-B'. Assuming a 30° northeasterly dip on a primary fault strand that projects upward to the base of the pre-1999 retaining wall, these profiles suggest a net shortening of about 1.3 m at this site. We speculate (as shown on Figure 18) that the dip of the fault decreases in the shallow subsurface, and daylights at the base of the topographic scarp. Based on these profiles, the shallow run-out of the thrust fault onto the pre-1999 ground surface is only a few meters wide. The area on the hanging wall of the fault is folded and deformed, as also illustrated by the presence of tilted betel nut trees along the scarp face (Figure 17). However, the drainage ditch at the base of the retaining wall remained open, in contrast to the ditch where it is adjacent to the tower (see below).

Figure 17a. Photograph looking northeast toward the Tsaotun Water Tower and along the Chelungpu fault, showing tilted trees on scarp face south of tower (photo taken June 9, 2001).

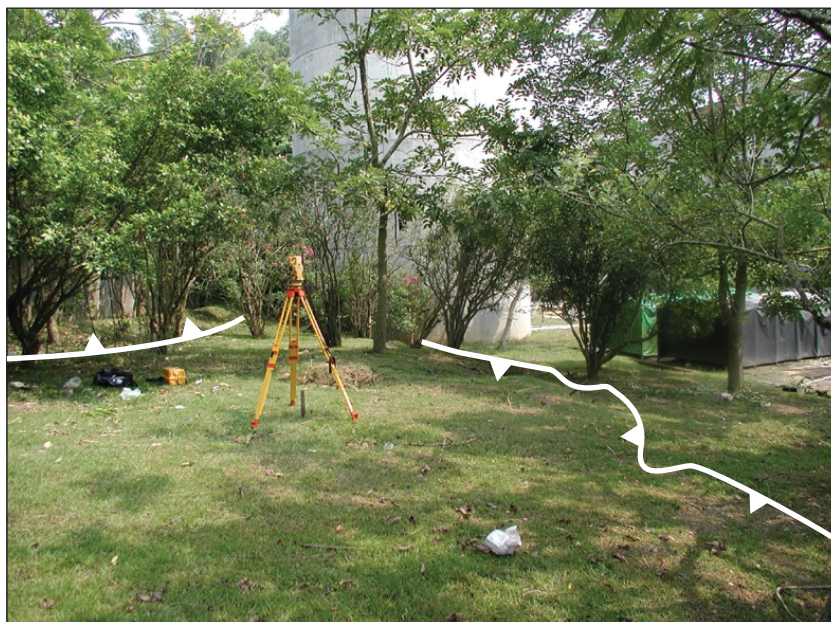
Figure 17b. Photograph looking south toward the Tsaotun Water Tower from hanging wall of the western fault strand. Eastern fault strand shown on left side of photograph (photo taken September 10, 2001).

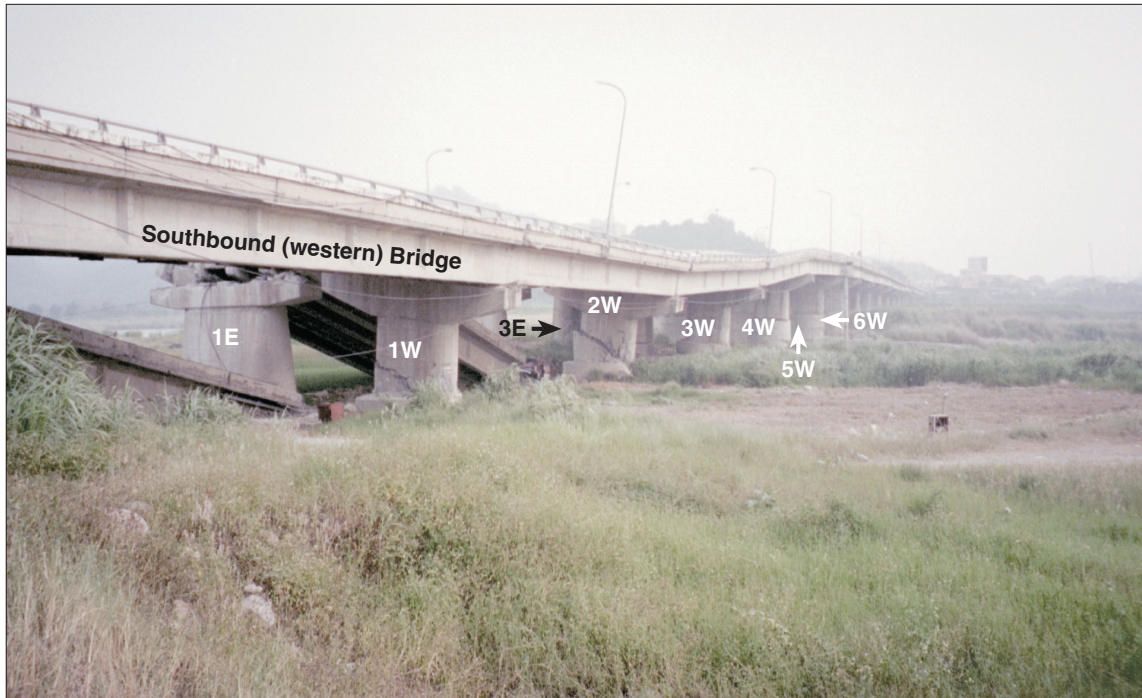
Figure 20a. Photograph looking south along the Wu Hsi Bridge, showing shear fractures in Piers 1W and 2W and two collapsed spans of eastern bridge. Note uplifted bridge spans south of Piers 4W in background (photo taken October 12, 1999).

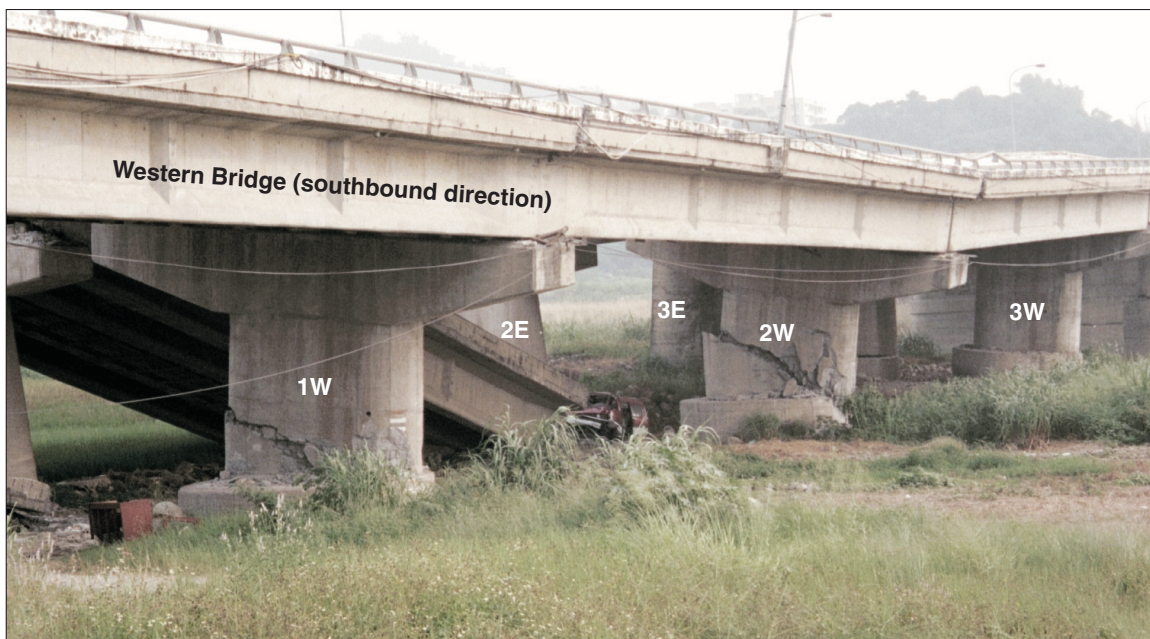
Figure 20b. Photograph looking southeast at the northern part of the Wu Hsi Bridge, showing shear fractures in Piers 1W and 2W. The Chelungpu fault strands run through piers 3W, and 3E, which are tilted toward the viewer (photo taken October 12, 1999).

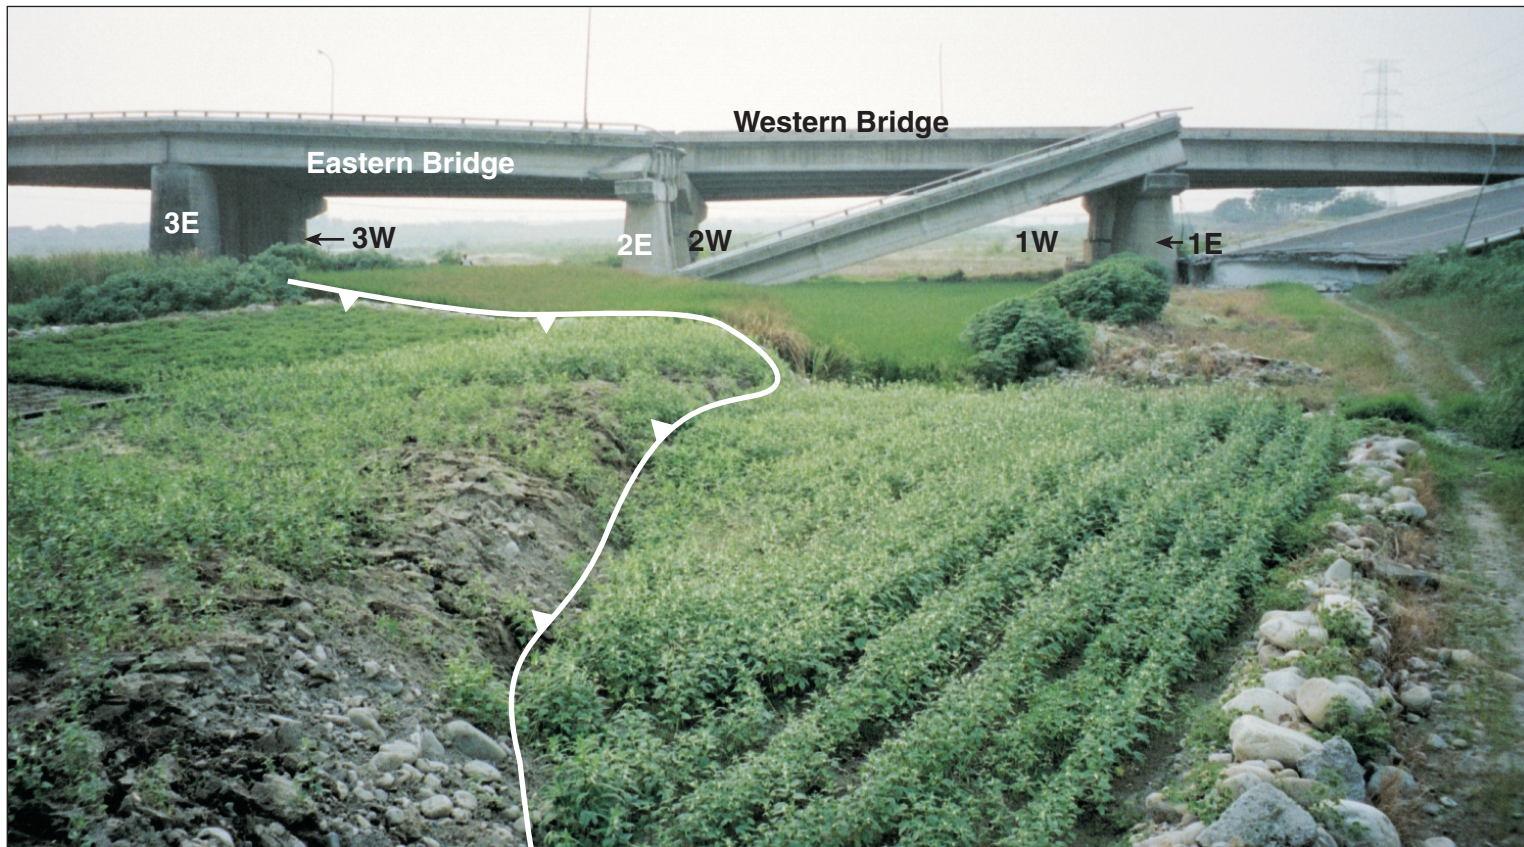
Figure 25. Photograph looking west of the northern part of the Wu Hsi Bridge, showing Chelungpu fault scarp in foreground and Highway 3 in background. The two collapsed northernmost spans of the northbound (eastern) bridge are on right side of photograph. (photo taken October 12, 1999).

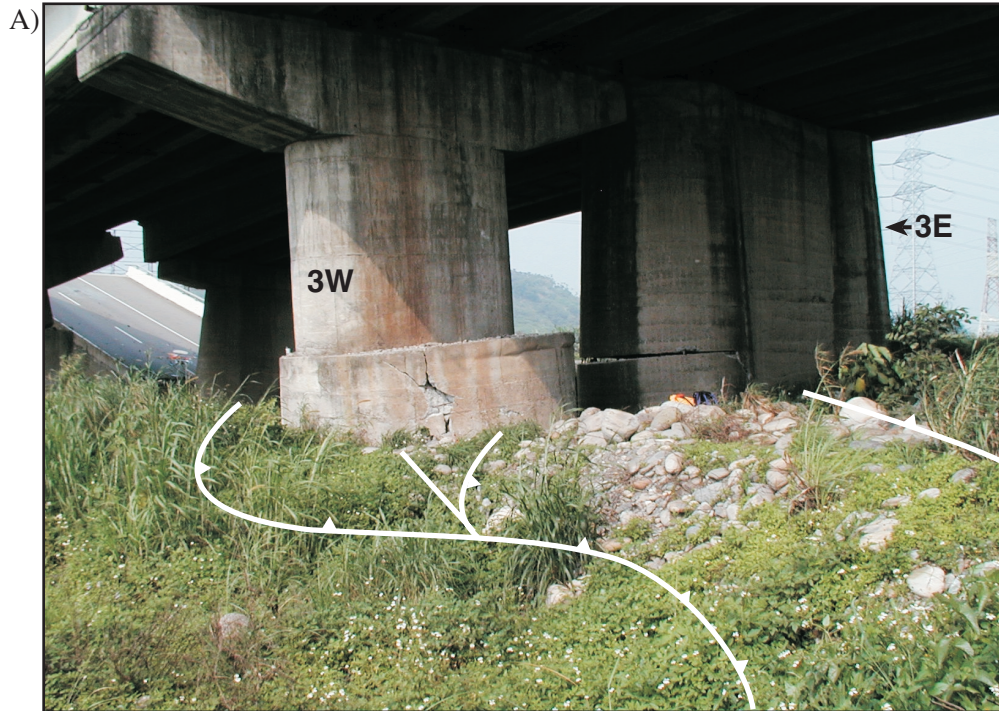
Figure 26a. Photograph looking northeast along western strand of Chelungpu fault at the Wu Hsi Bridge site, showing west-facing fault scarps and damage to Piers 3W and 3E. Collapsed bridge span and Pier 2E in left background (photo taken April 9, 2000).

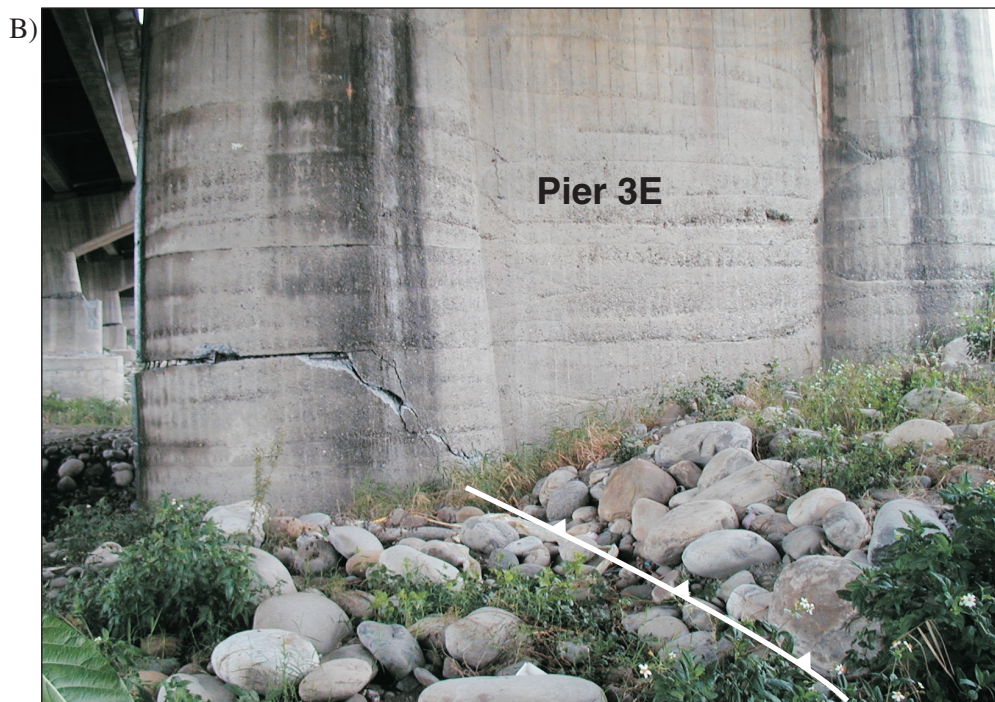
Figure 26b. Photograph looking north at Pier 3E along the eastern fault strand, showing east-dipping fracture in pier and west-facing fault scarp (photo taken April 15, 2000).
